# A5 Oswestry UV Lining Works

**Project Activity:** Drainage surveys & UV lining works

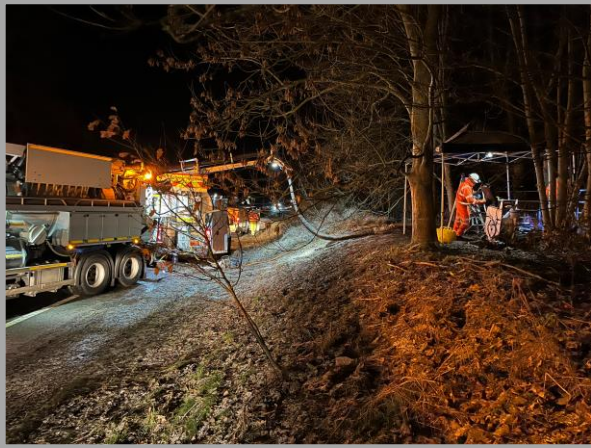
Upon undertaking the drainage survey works we identified that there were large sections of the drainage system impacted with tree roots. After undertaking extensive root cutting to clear the drainage system we installed three liners totalling 150m in length in the 225mm diameter drainage system. The liners were installed using our liner using our new Speedy Light+ LED curing system.

By undertaking the repair works using this method allows our site teams to reduce the time it takes to cure a liner by up to six times. Using this technology, we can install and cure felt liners, invertible glass-fibre liners and glass fibre pull in liners.
